WEARE, NEW HAMPSHIRE

**WEARE RESERVOIR DAM  
NH 00114**

**PHASE I INSPECTION REPORT  
NATIONAL DAM INSPECTION PROGRAM**

**AUGUST 1978**

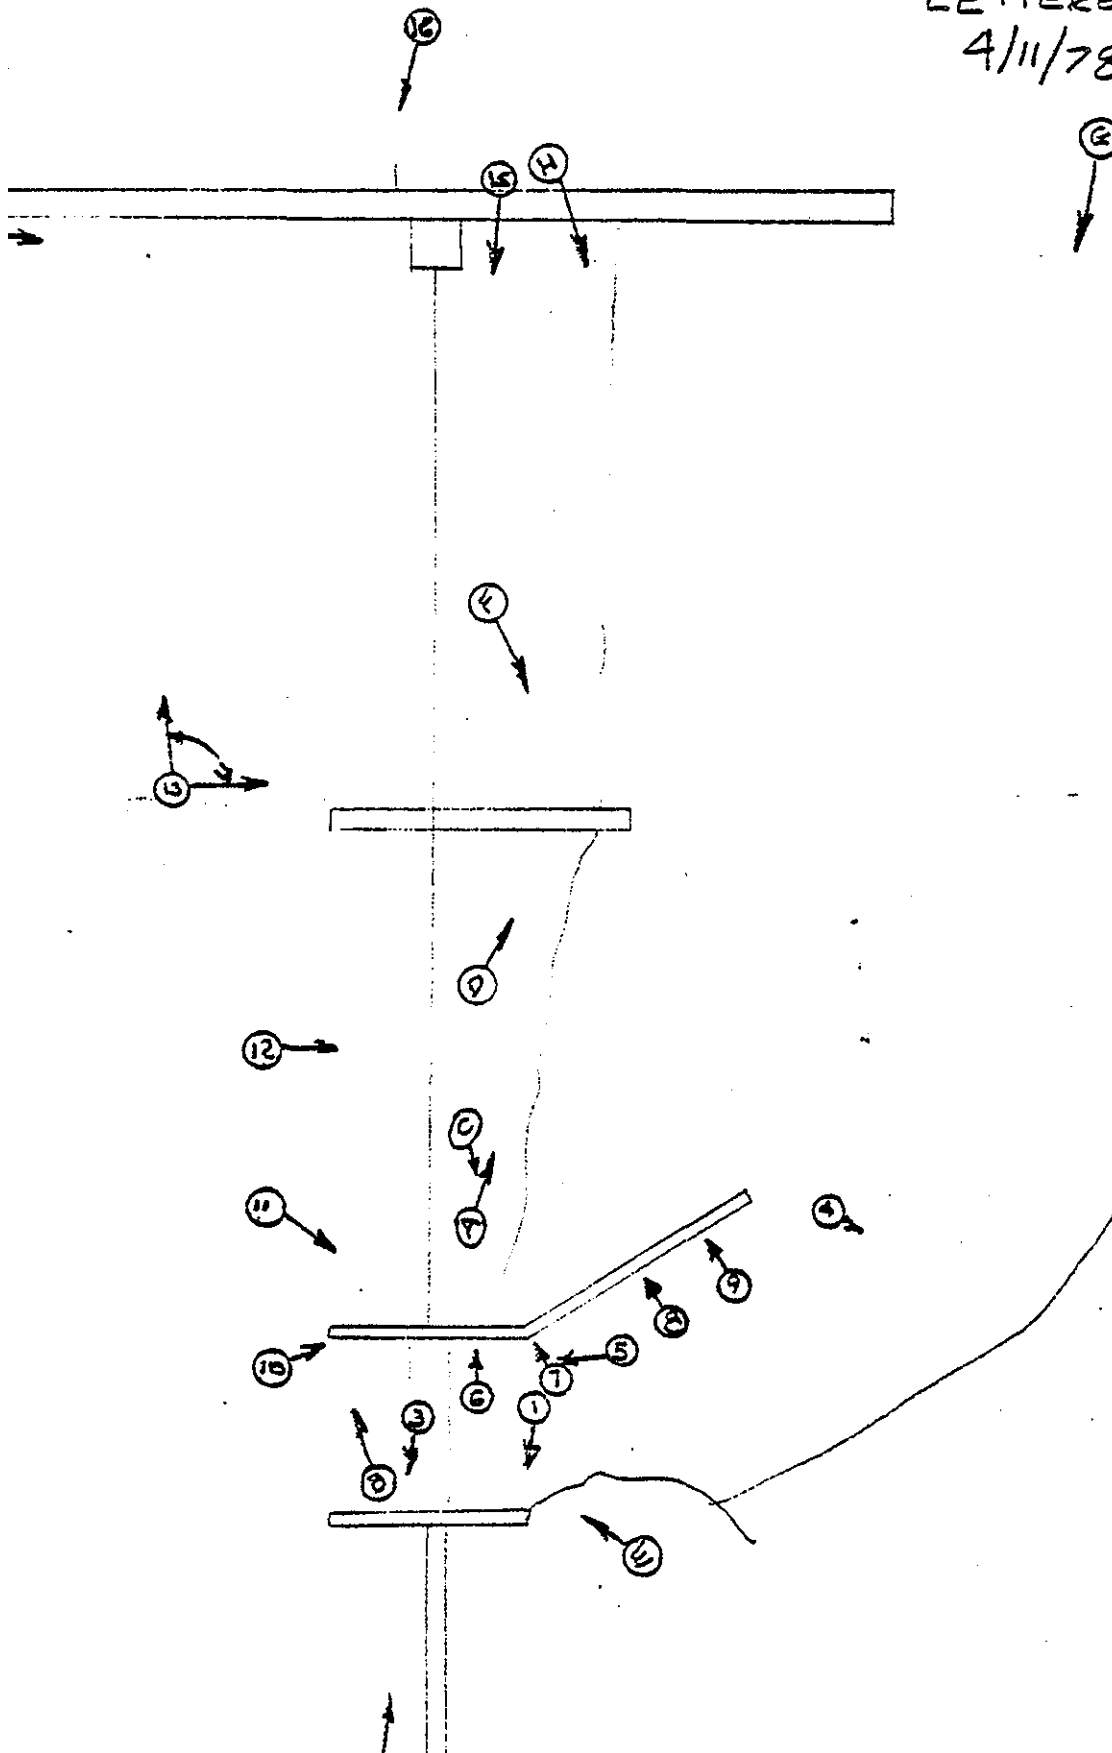
CRACKS

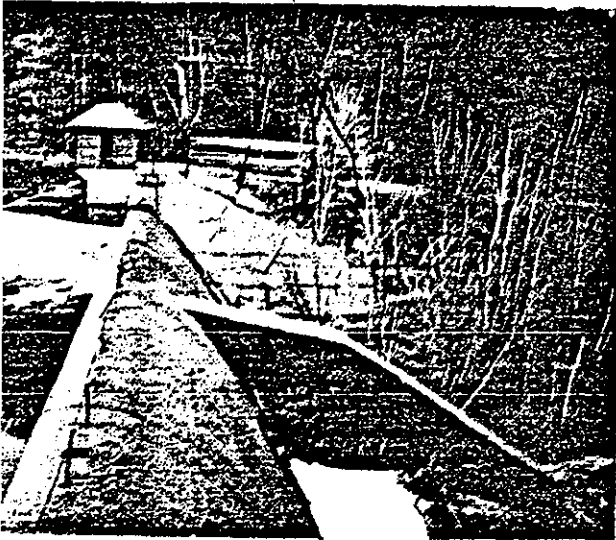
WATER FLOWING UNDER  
CONCRETE

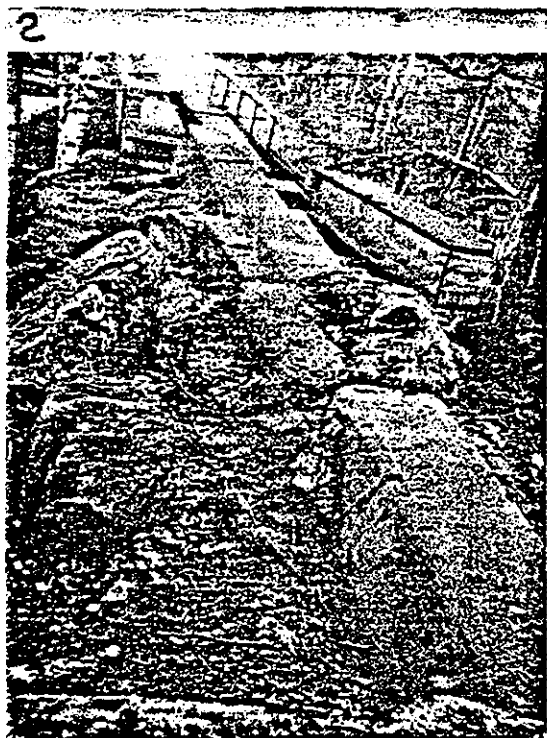
Cold Joint

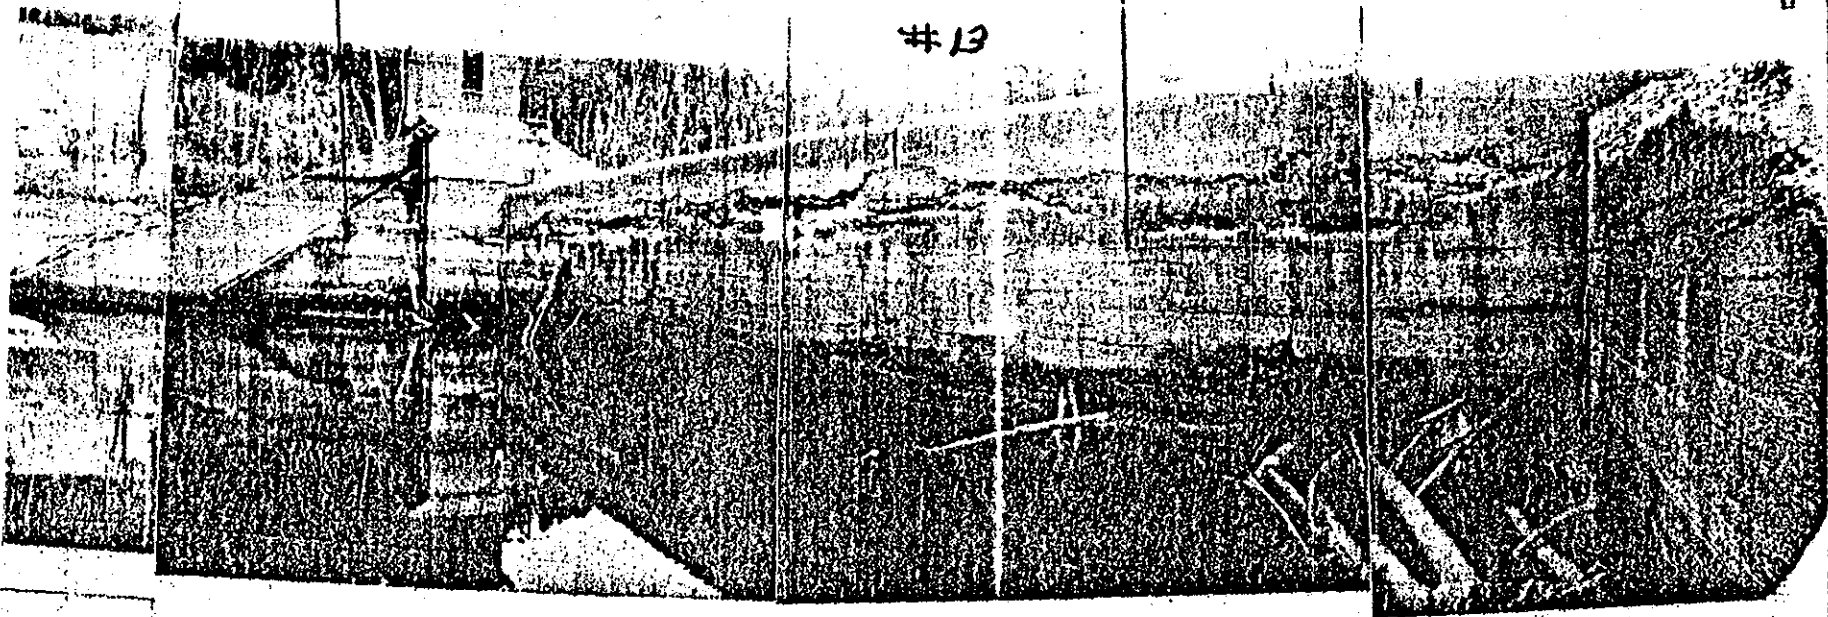
#13

Cold Joint

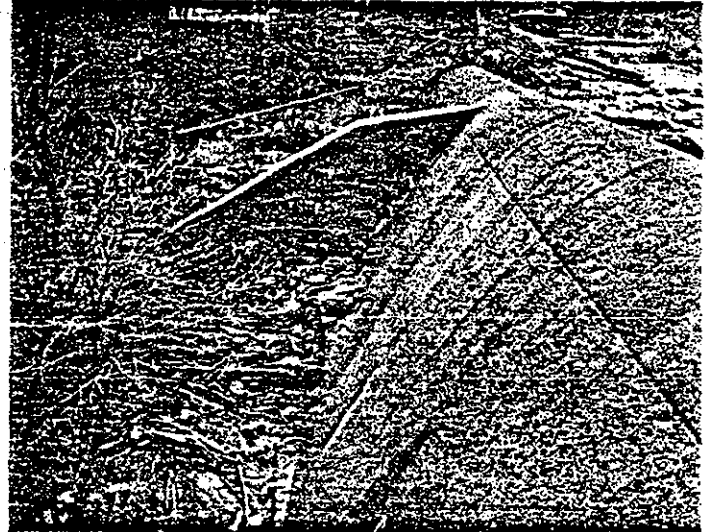
# 15

Cold Joint

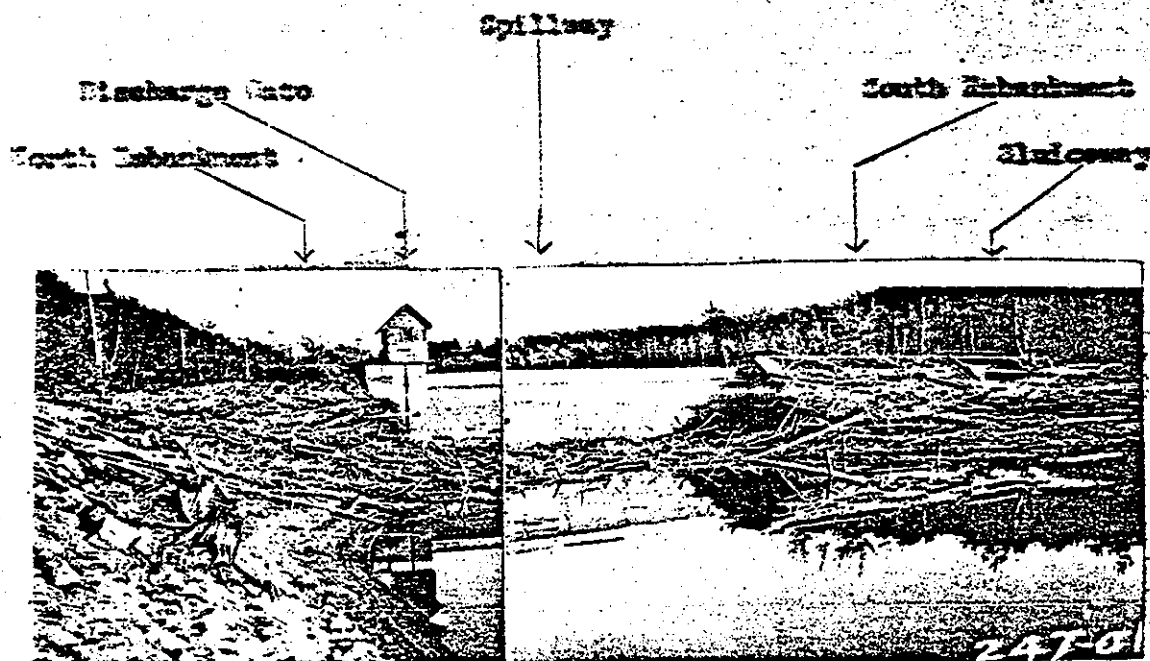
FIGURE 2. DAM BEFORE WASHOUT  
LOOKING DOWNSTREAM

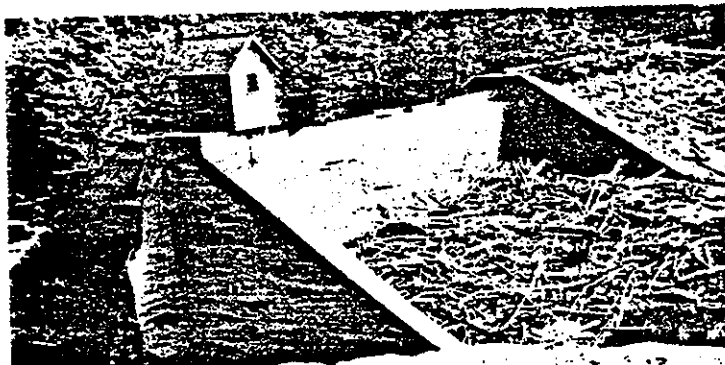
LEFT ABUTMENT WASHED  
OUT IN 1938 FLOOD

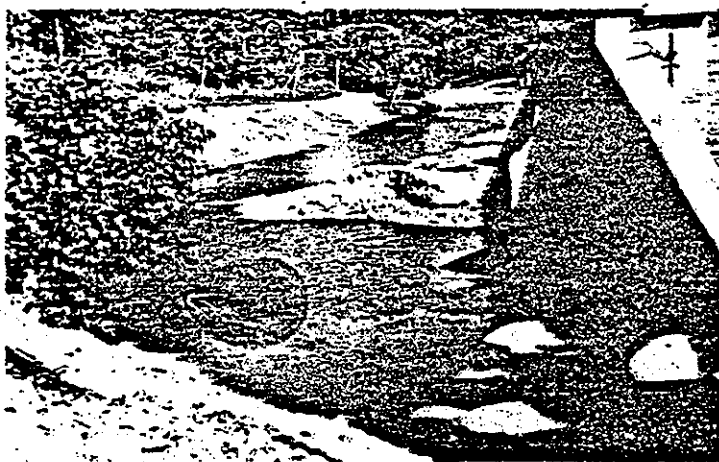
Figure 3. Pictures Showing Condition  
of North Embankment after Washout

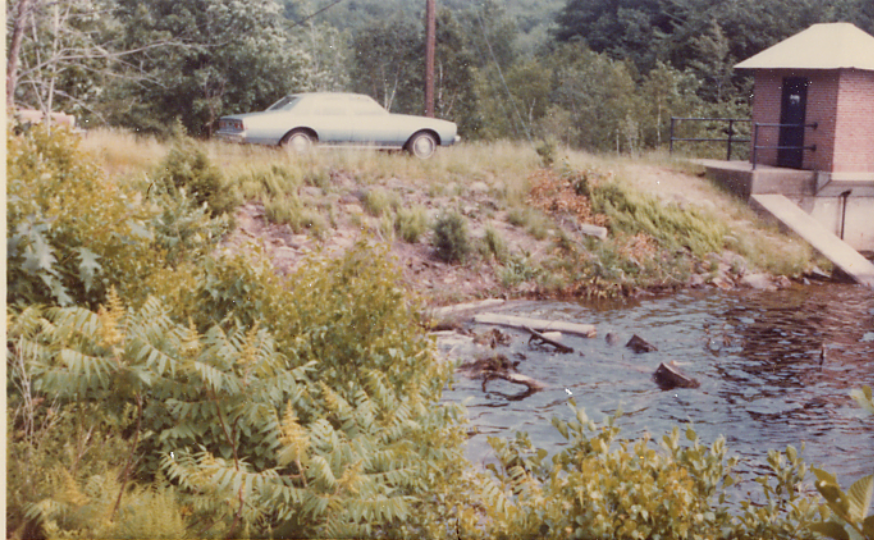
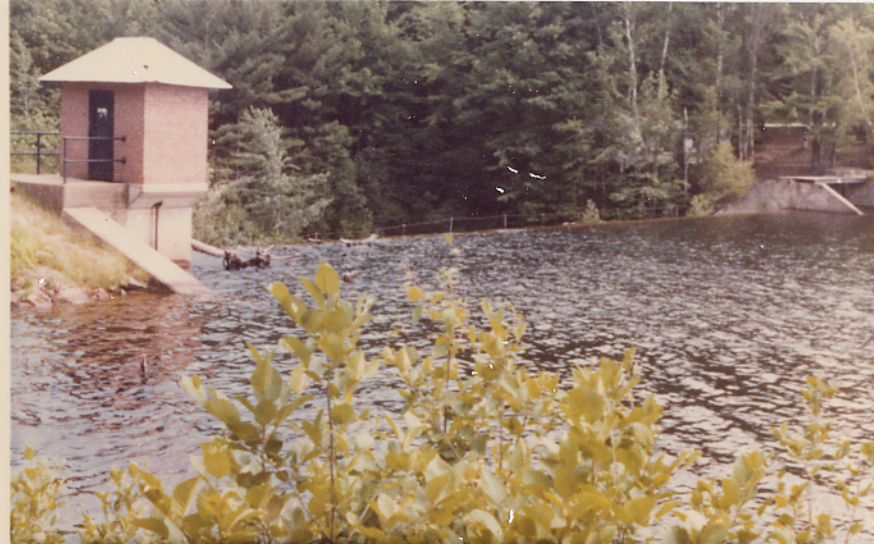
<u>Photo No.</u>	<u>Description</u>
1-2	2 photo clockwise sequence looking from road upstream of north end at the upstream face of the dam. Note log debris in water and eroded path and embankment face next to abutment.
3	Looking south across crest from top of north embankment. Note spalling on face of middle wall.
4	Close-up of eroded path on upstream face of north embankment next to concrete abutment. Taken from gate house platform looking down.
5-6	2 photo clockwise sequence looking from downstream channel at downstream face of dam. Note rocks and debris in channel, undermined end of training wall and trees growing in channel.
7	Looking north across crest from top of stoplog spillway. Note log debris on north end of spillway, spalled face of middle wall and slight bow to catwalk.
8	Looking at downstream south bank. Note soil being undermined adjacent to cabin, exposed ledge and trees leaning toward downslope.

- (1) Provide erosion protection on the crest of the north embankment (e.g. paving or grass) and take measures to prevent unauthorized vehicle access to the crest.
- (2) Repair the soil erosion on the upstream face of the north embankment adjacent to the concrete abutment.

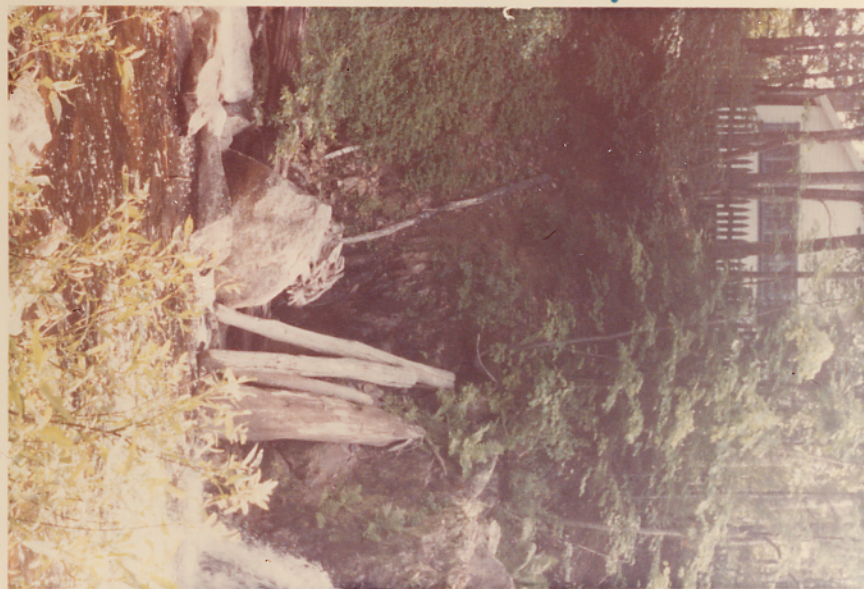
8

Soil erosion is occurring on the upstream face of the north abutment and also along the south downstream bank, caused by discharge flow from the stoplog spillway. The latter is progressing towards undermining the foundation of a small private cottage.
